Fire resistance test utilising the general principles of BS 476: Part 20: 1987 on two specimens of penetrating sealing systems.

175941

Culimeta-Saveguard Ltd

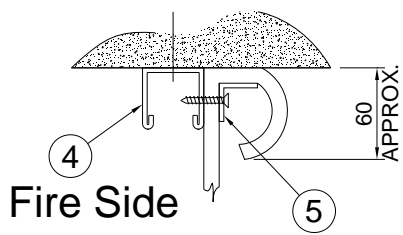
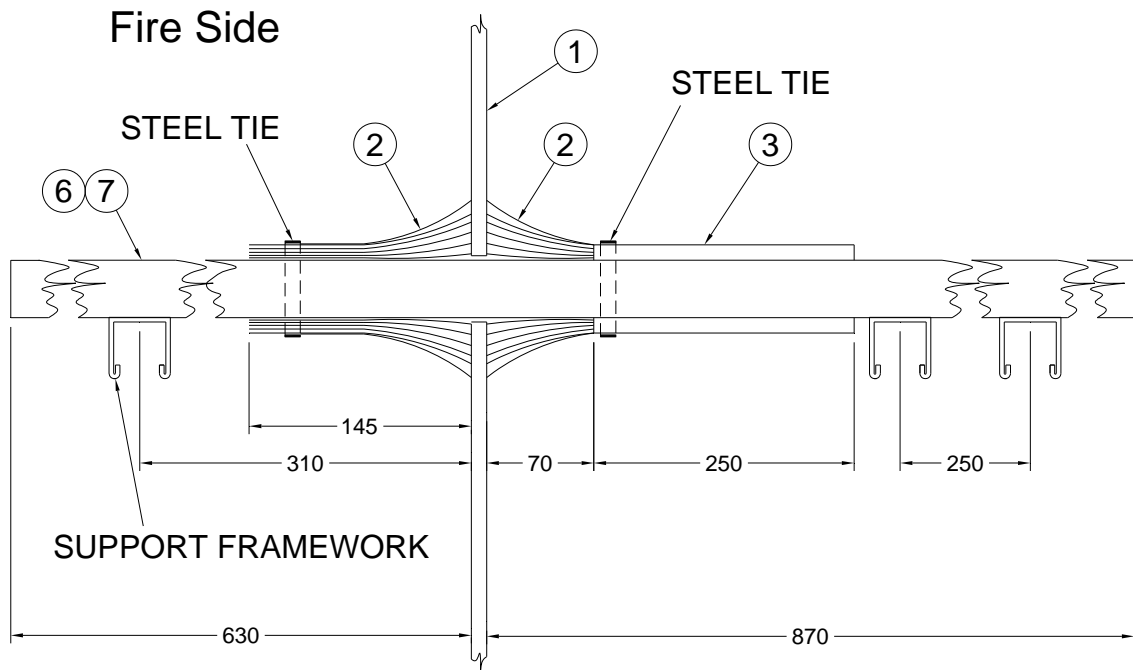
Figure 2 – Typical sections through barrier and penetration seals

SECTION 'A-A'

SECTION 'B-B'

SECTION 'C-C'

i. perimeter to concrete frame	: 60 mm folds and clamped as shown in Figure 2
ii. vertical joints	: 60 mm folds, fixed with 2 rows of size 10 galvanised steel staples at 100 mm staggered vertical centres, see Figure 2.
Nominal thickness	: 7.1 mm

i. material	: Galvanised mild steel
ii. thickness	: 1.5 mm
iii. size	: 150 mm wide x 10 mm folded edges
iv. length	: Continuous length
Cables	
i. type	: Electrical copper core cables
ii. sizes (left to right viewed from unexposed face)	: 1 No. 25 mm overall diameter 1 No. 12 mm overall diameter 2 No. 15 mm overall diameter
Fixing	: Cables fixed with ties to cable tray. Cable tray supported by a framework of steel channels at centres shown in Figure 2

7. Pipe penetration – Specimen 'B'	
Material	: Mild steel pipe
Thickness	: 3 mm
Diameter	: 60 mm
Length	: Continuous length
Fixing	: Pipe fixed with steel wire a framework of steel channels at centres shown in Figure 2

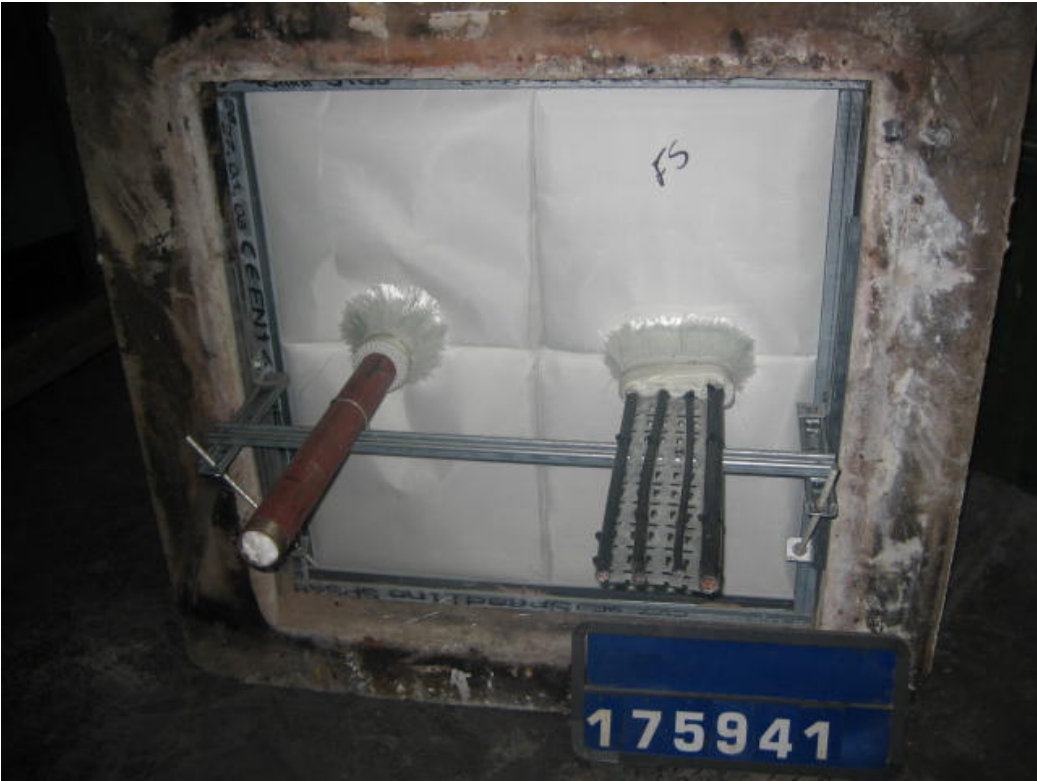
The exposed face of the seals prior to testing

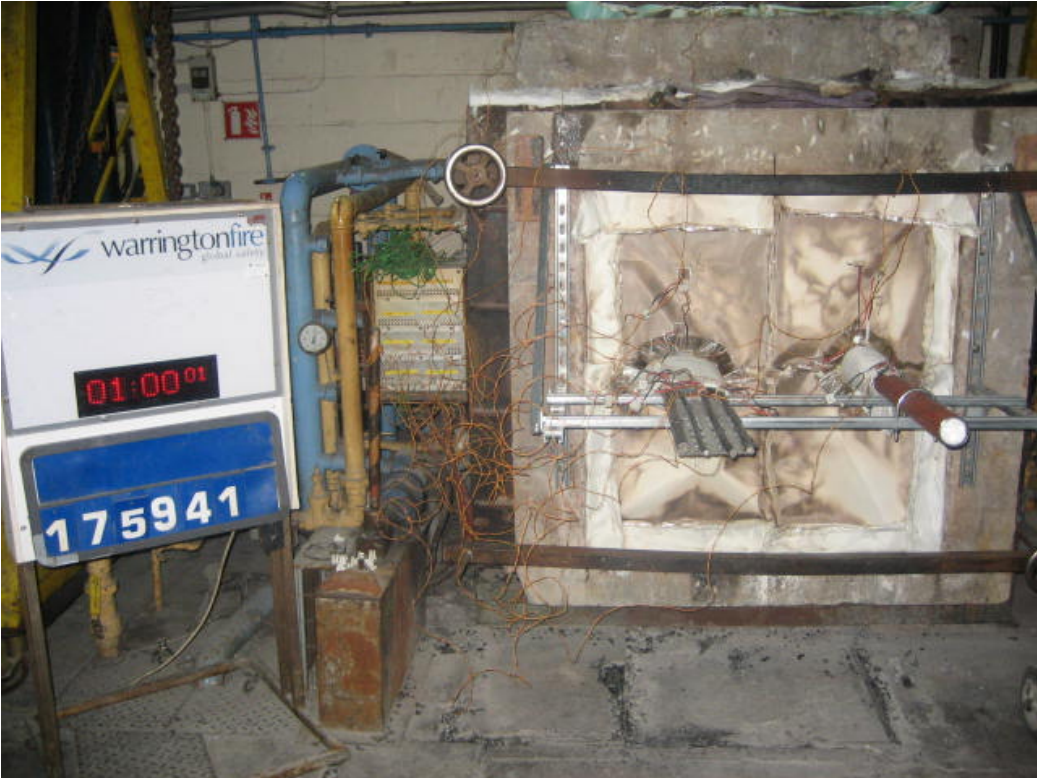
The unexposed face of the seals after a duration of 60 minutes

Time		All observations are from the unexposed face unless noted otherwise.
mins	secs	The ambient air temperature in the vicinity of the test construction was 18°C at the start of the test with a maximum variation of 2°C during the test.
00	00	The test commences.
10	00	The material in the wall construction has started to discolour.
15	05	Maximum temperature rise recorded on Thermocouple No. 17. Insulation failure is deemed to have occurred.
30	00	All of the specimens continue to satisfy the integrity criteria of the test.
45	00	No further significant visible change.
60	00	All of the specimens continue to satisfy the integrity criteria of the test.
63	00	Glowing areas are visible in the fabric near to thermocouple No. 8.
66	00	The test is discontinued.

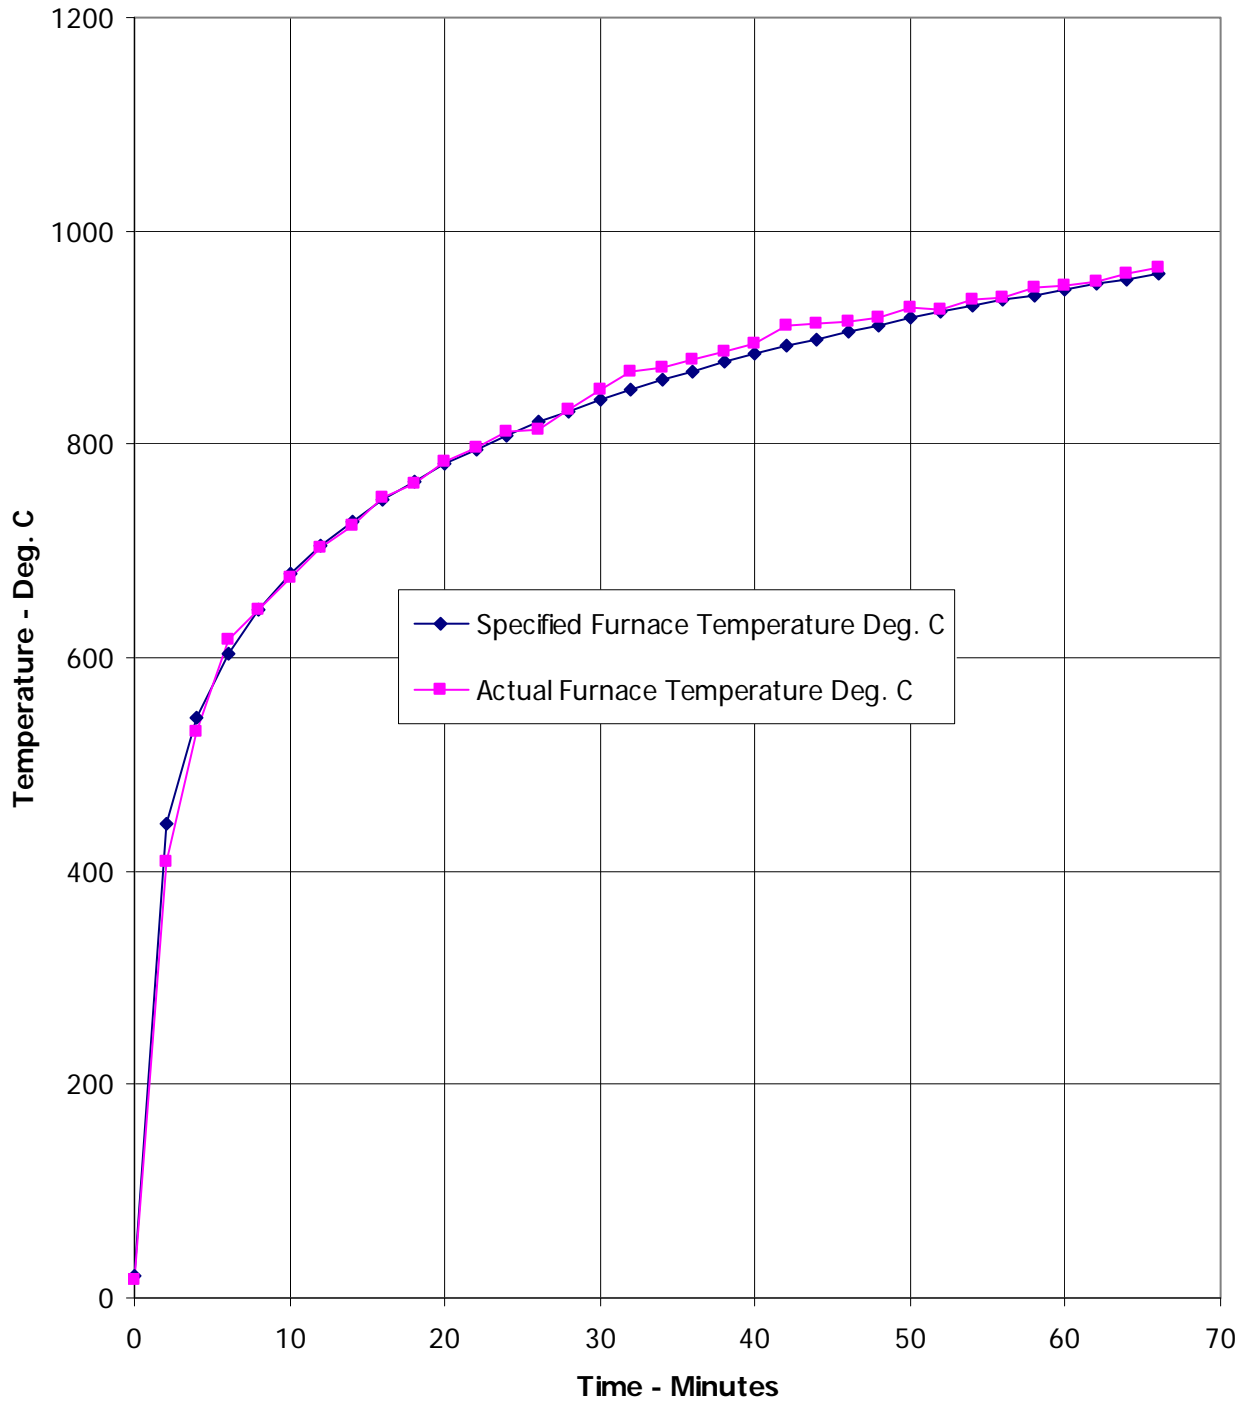
Graph Showing Mean Furnace Temperature, Together With The Temperature/Time Relationship Specified In The Standard

Time Mins	Specified Furnace Temperature Deg. C	Actual Furnace Temperature Deg. C
0	20	17
2	445	409
4	544	531
6	603	617
8	645	645
10	678	675
12	705	704
14	728	723
16	748	750
18	766	763
20	781	784
22	796	798
24	809	812
26	820	814
28	832	833
30	842	851
32	851	868
34	860	872
36	869	879
38	877	887
40	885	894
42	892	911
44	899	913
46	906	915
48	912	919
50	918	928
52	924	925
54	930	936
56	935	937
58	940	947
60	945	949
62	950	952
64	955	959
66	960	966
